AGENDA
ENVIRONMENTAL ADVISORY BOARD
CITY OF PORT ORANGE

SUBJECT: Recommendation of Mitigation Options for the Removal of a Historic Live Oak Tree at 164 Sweetgum Lane

Re: Tree Health and Risk Assessment for one (1) live oak (*Quercus virginiana*).

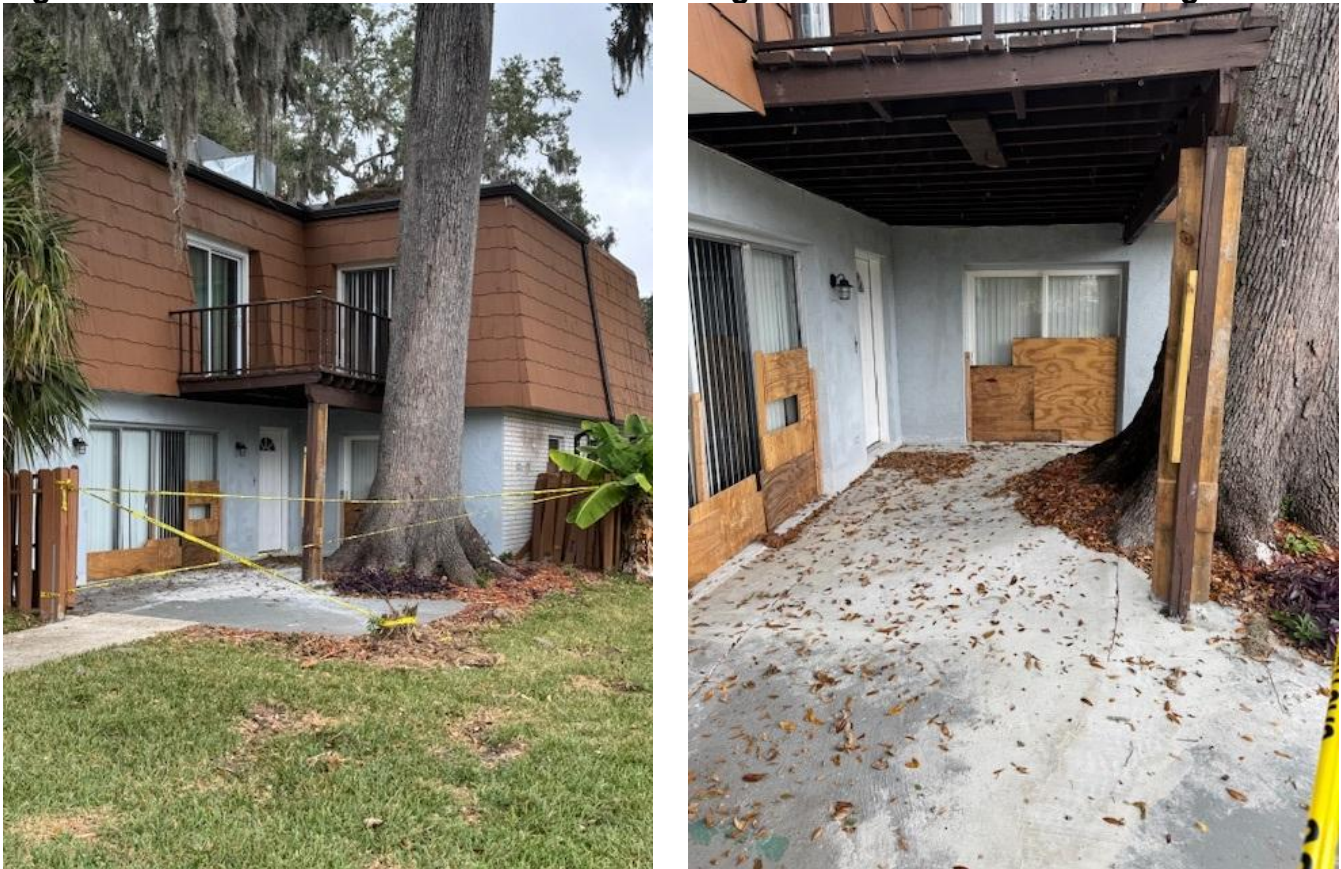
Figure 2. Pictures of the Historic Tree and damage it has caused at 164 Sweetgum Lane

In January 2026, the property owner submitted a tree removal permit to remove the 45-inch diameter at base height (DBH) historic Live Oak tree. Ray Jarrett, Biologist/Arborist, has evaluated the tree and determined the tree is a historic Live Oak with a diameter at breast height (DBH) of approximately 45” and approximately 70’ tall (Exhibit 1) and did not display sign of disease. The report states that the tree grows directly in front of the townhome unit at 164 Sweetgum Lane. According to the property owner, the tree is less than 1’ foot away from the second-floor deck, and several lateral roots have undermined the deck support beams and foundation of the home. City staff have observed that the tree’s roots are lifting the patio slab, pitching the patio slab and surrounding yard back towards the structure.

According to an Arborist Report, the subject tree is located less than one (1) foot from an attached second-floor deck and approximately 5 to 6 feet from the residential dwelling unit. Although the tree is currently classified as healthy, its proximity to the townhome unit has created an ongoing and worsening nuisance condition for the property owner.

The homeowner reports that temporary, short-term measures, such as sealing cracks and caulking openings, have been implemented; however, these efforts have provided only limited relief and do not address the underlying cause of the issue. The primary concern appears to be the tree's root system, which has caused lifting and buckling of the slab and surrounding yard.

The altered patio and grading now slopes toward the townhome units, directing stormwater toward the townhome unit.

The homeowner's contractor has determined that the only permanent and effective solution to correct the drainage issues is the removal of the tree and stump, followed by removal and replacement of the existing patio slab with a new slab properly sloped away from the structure and regrading of the surrounding area to direct runoff toward the development's drainage system and this corrective action cannot be completed while the tree remains.

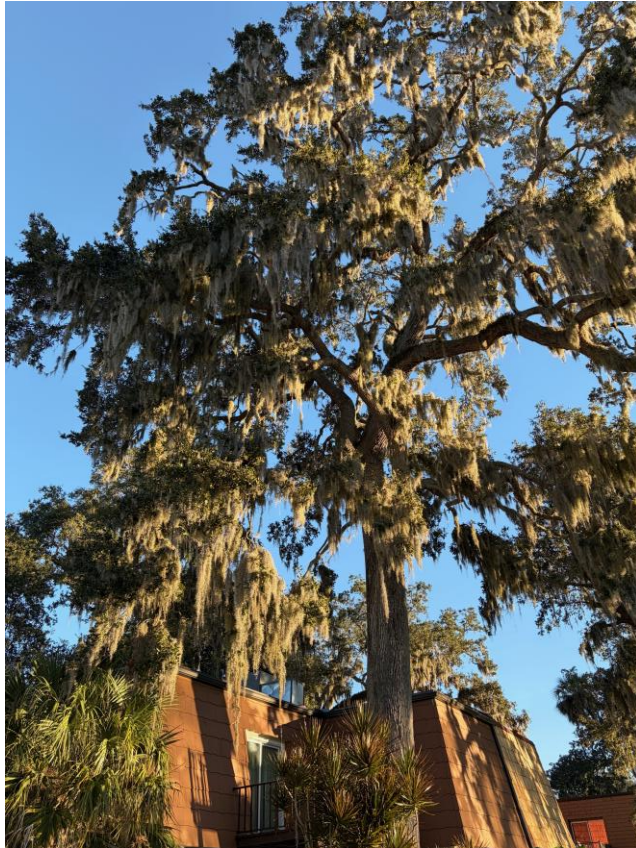
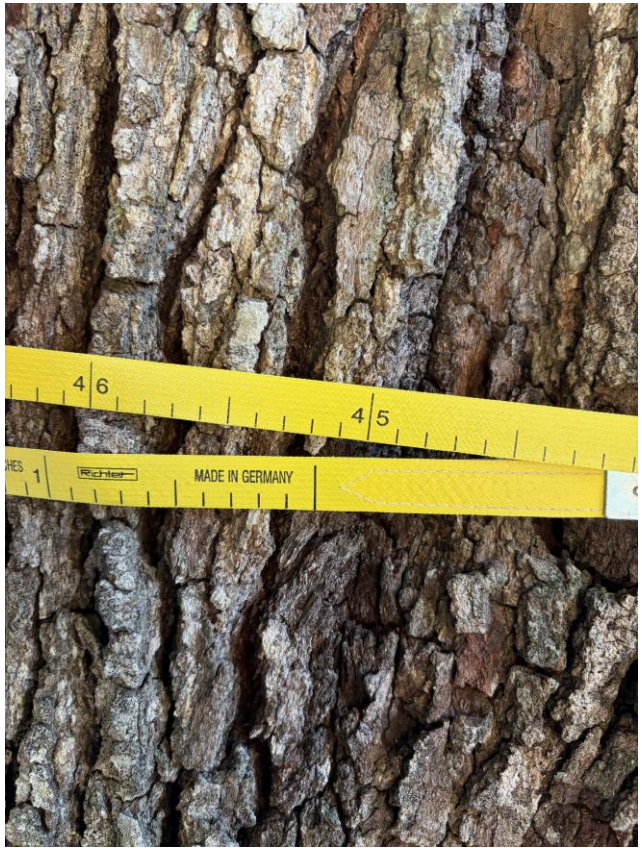
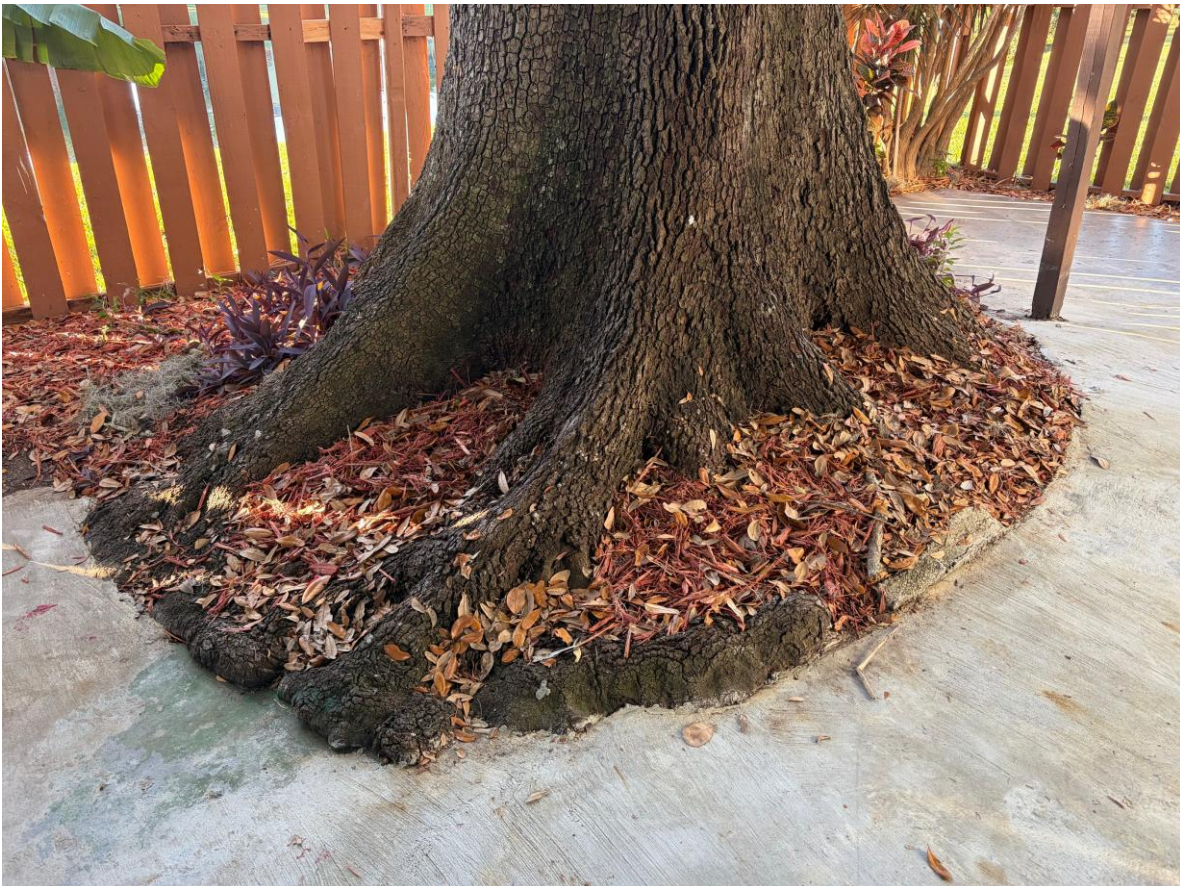
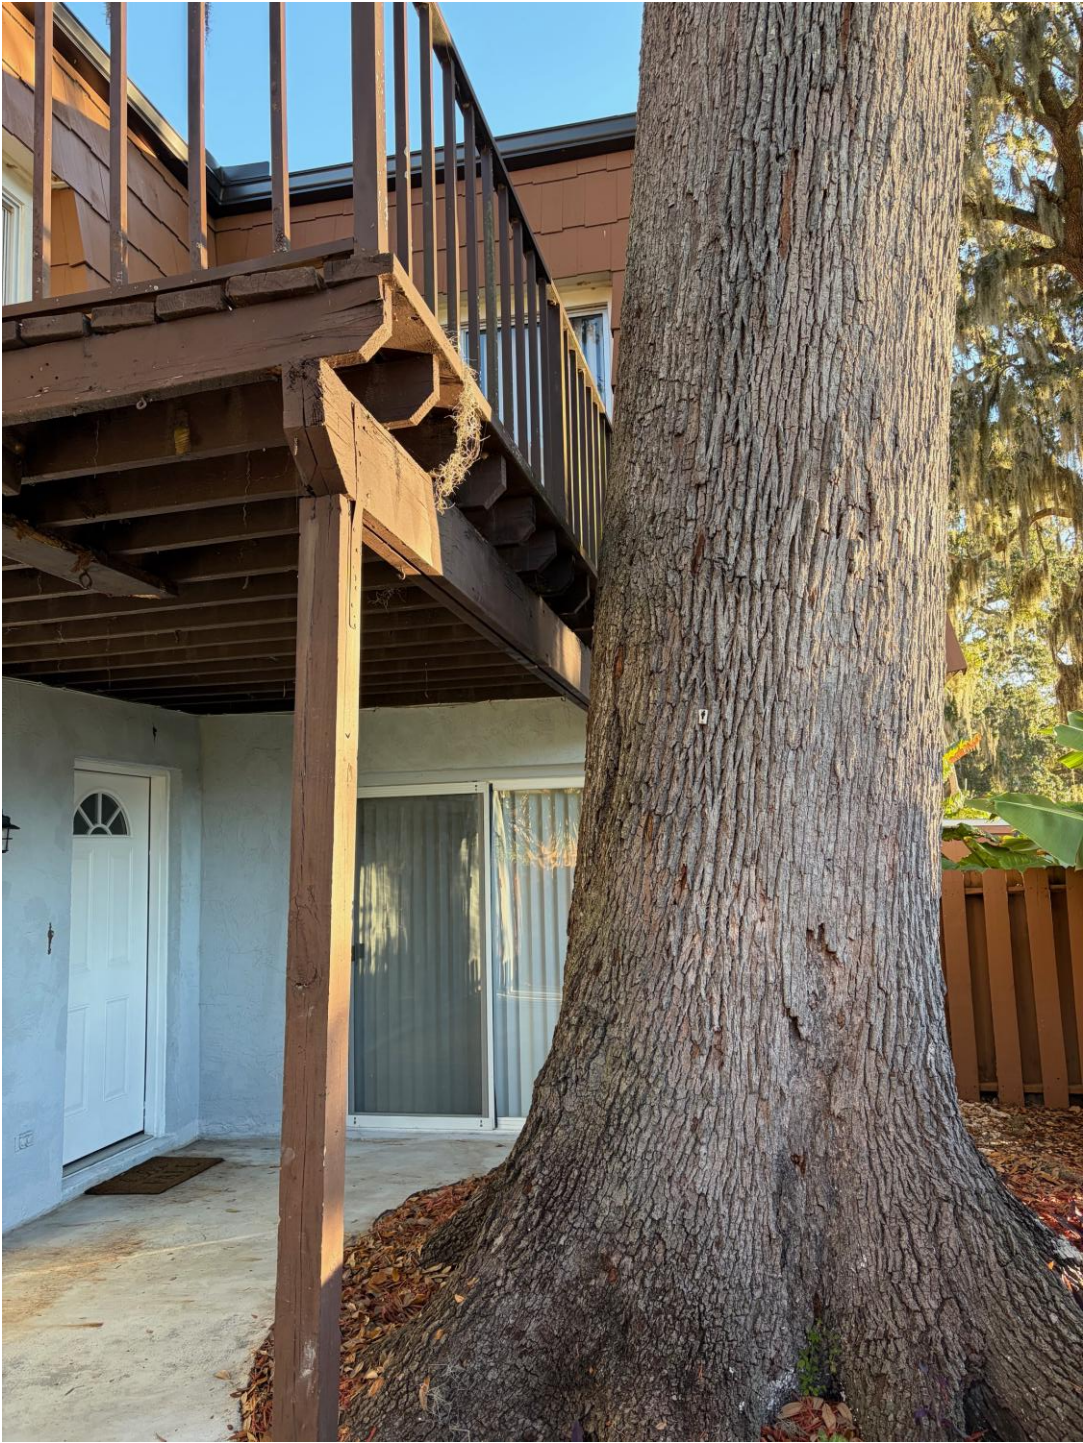
Documentary Photographs:

This tree is approximately 70' tall with a DBH of 45" and a LCR of around 50%. This tree grows directly behind the home, adjacent to the second-floor open deck. The main stem is less than 1' foot away from the deck. This tree is healthy and vigorous, and several lateral roots have undermined the deck support beams and foundation of the home. This tree is a Historic tree as defined by the City of Port Orange code:

Tree risk assessment does not consider root impacts to infrastructure in the ratings and only documents these impacts in this report. Cutting away lateral roots, grinding, and excavating beside this tree could cause it to be poorly anchored and unstable, increasing the overall risk rating. Removing these trees is the only practical solution for the property owner.

1. Prune to reduce the length of lateral branches and tree height by 30 - 50%. Reducing the height and length of lateral branches that cover targets could reduce the risk from **Moderate** to **Low**.
2. Do nothing and continue to monitor the tree with regular inspections.
3. Remove the tree. This would eliminate all risk.

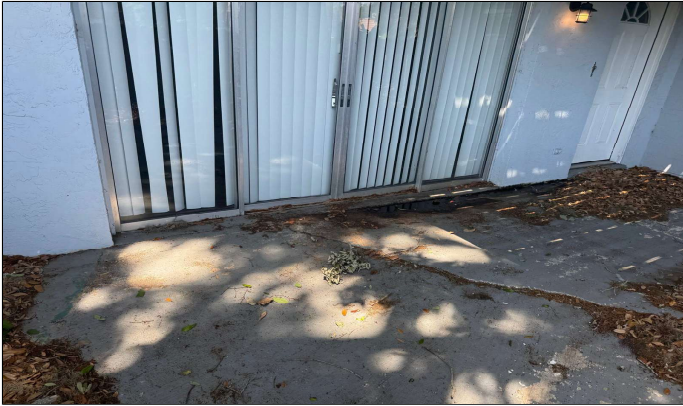
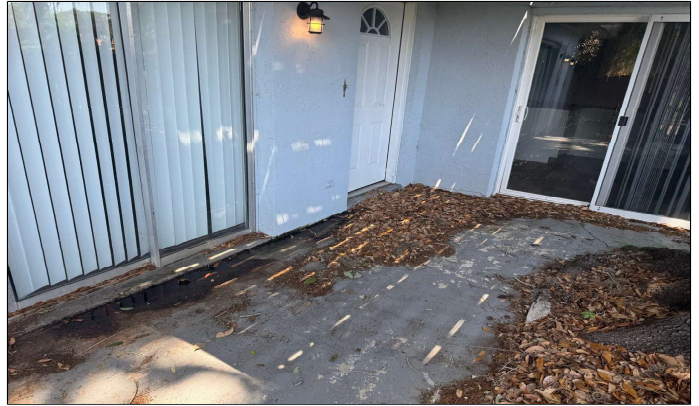
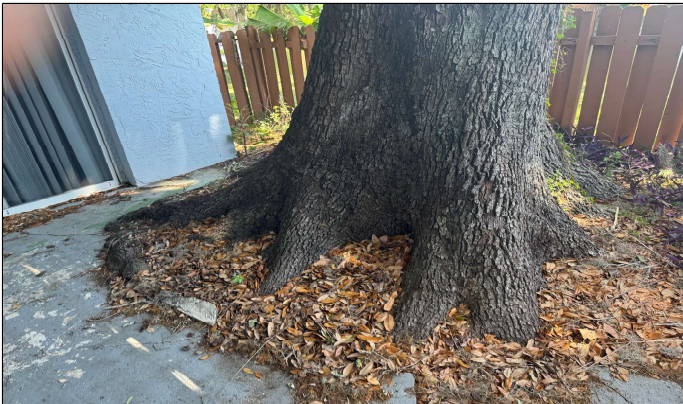
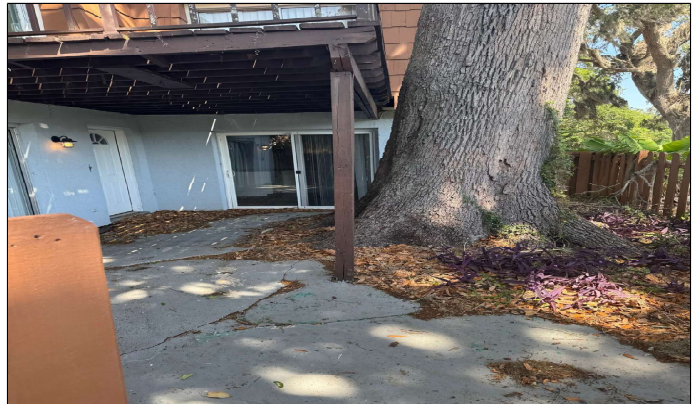
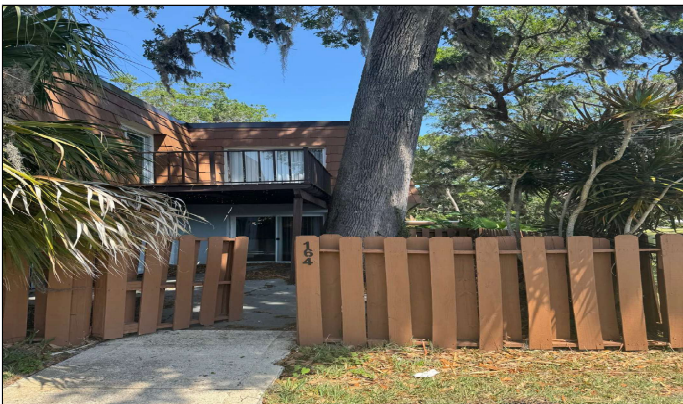
Photos

2. Tree and Patio Issue: A large tree at the entrance has caused the concrete patio to buckle and slant toward the unit, exacerbating the water intrusion problem. The tree is part of the HOA-maintained exterior, but the HOA has stated that the tree is the owner's responsibility.

Issue: Water pooling by the front door, and living room glass door. Moisture is getting in the unit.
Permanent solution: Remove the tree and the stump that is grooving in the front yard. Remove and redo the patio slab with a proper slope away from the unit. Not able to complete this work as it requires services of a tree removal company.
Long Lasting but NOT permanent solution: Cut out the 16 in of patio slab along the glass doors and install a drain pipe leading to the back and side yard of the property.
Install a water basin by the front door to accommodate water volume and connect it to the drain pipe under ground. Install furnace mount pool drain along the house to further assist in water diversion. Pour new concrete after installing the pipe.
Will require a dumpster to property dispose of all debris.
Labor and materials included. 3-4 days of work.

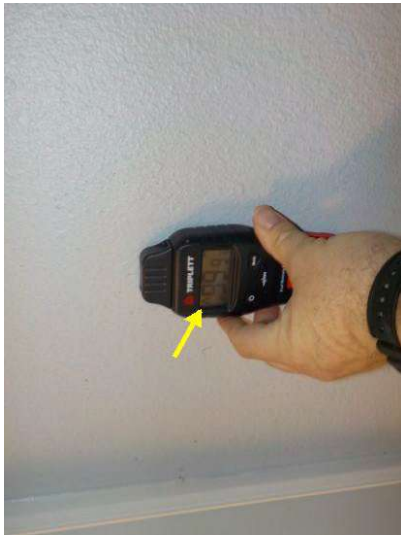
Advise several living room and kitchen walls are 66%-99% wet in numerous areas. Recommend having dehumidifiers placed in unit until moisture intrusion can be controlled.

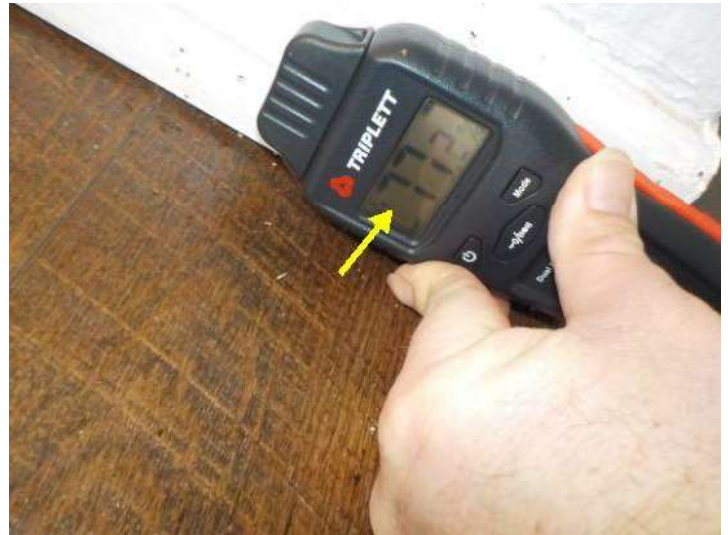
Advise several living room and kitchen walls are 66%-99% wet in numerous areas. Recommend having dehumidifiers placed in unit until moisture intrusion can be controlled.

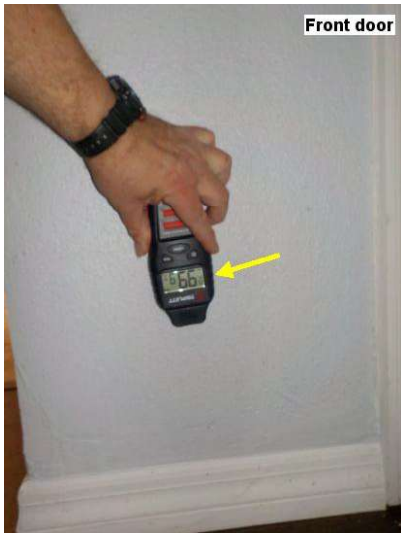
Advise several living room and kitchen walls are 66%-99% wet in numerous areas. Recommend having dehumidifiers placed in unit until moisture intrusion can be controlled.

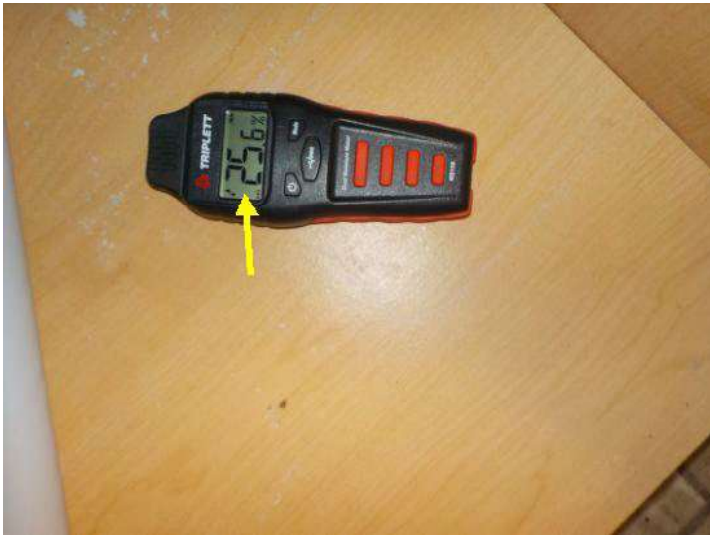
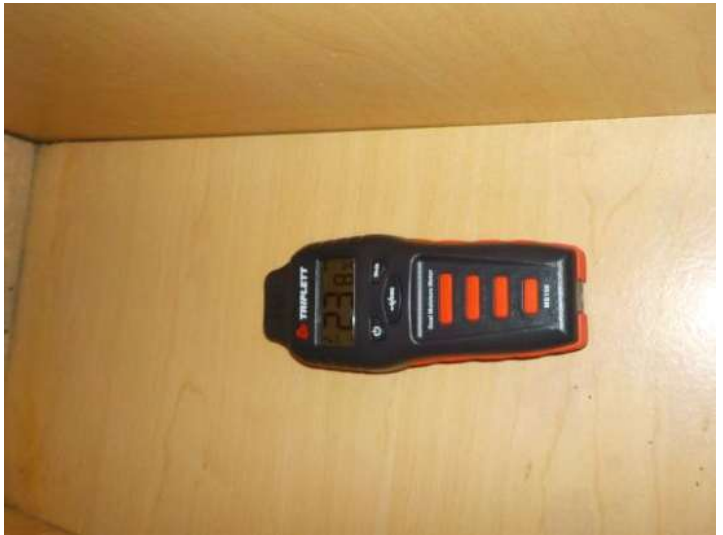
Advise cabinets 99% wet at bottoms and 25% wet on interior of most cabinets.

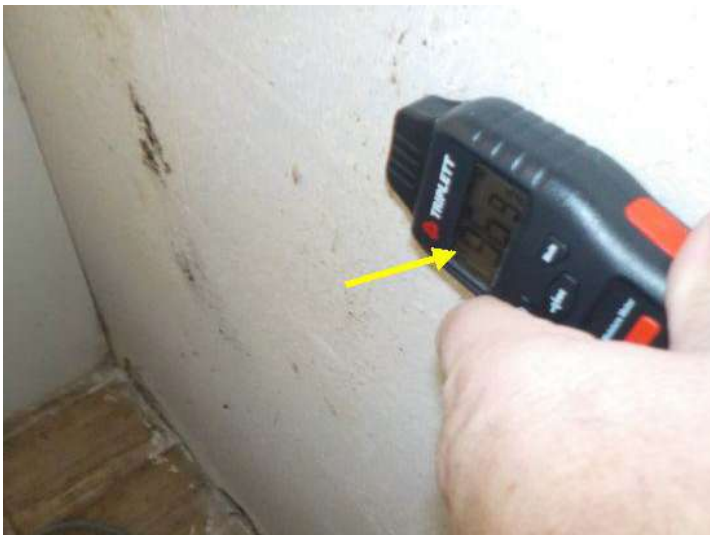
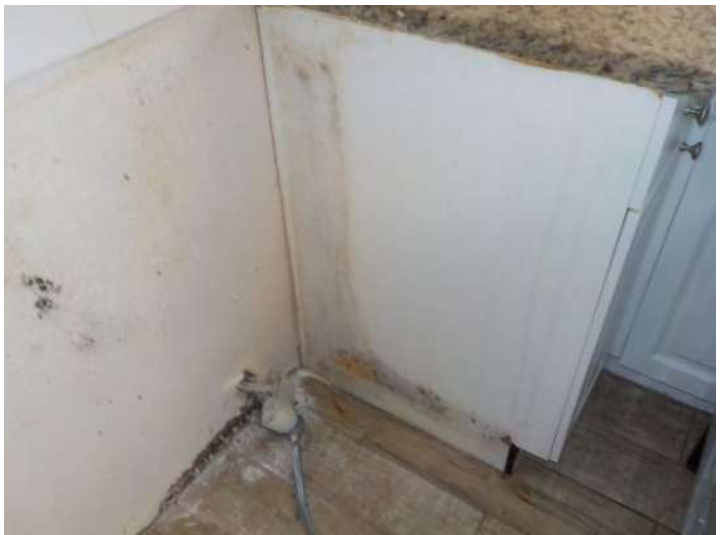
Advise wall behind stove 45-99% wet at time of assessment.

Recommend remove and repair if possible lower kitchen cabinets.

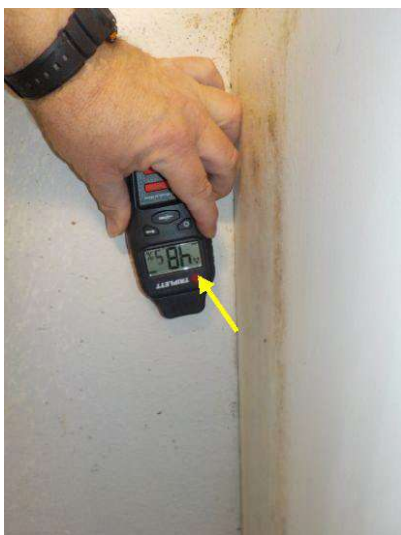
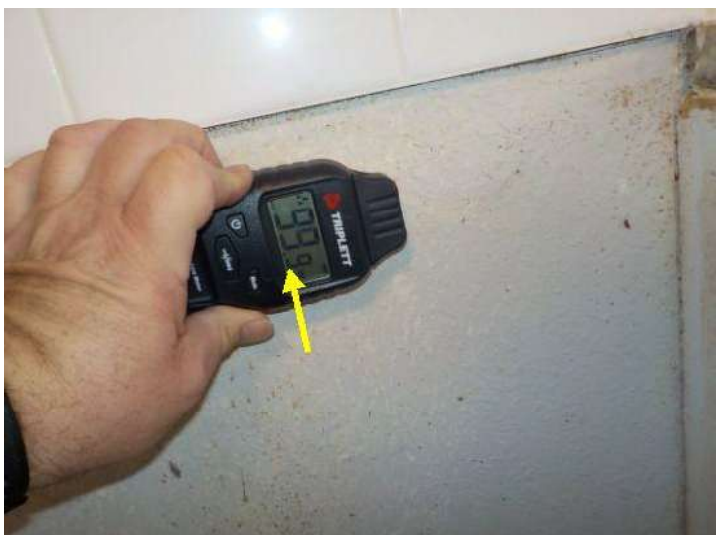
Advise wall behind stove 45-99% wet at time of assessment.

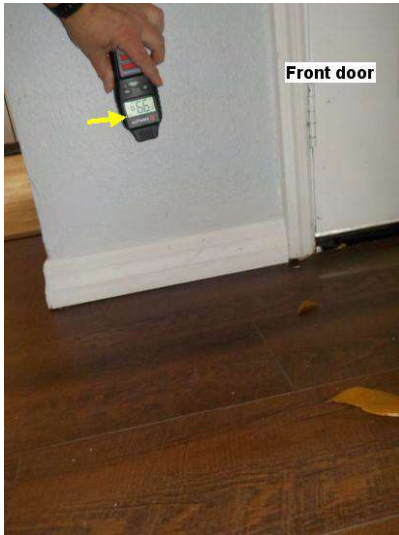
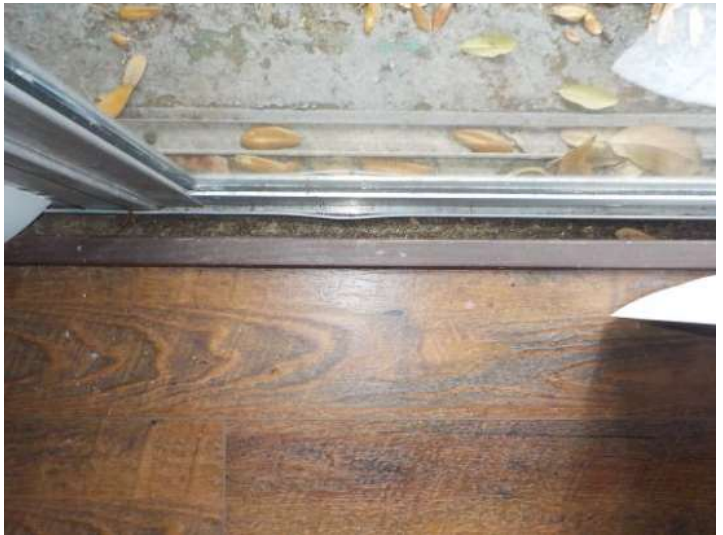
There is evidence of moisture intrusion Our moisture measuring instruments reveal a 40-99% level of moisture in the drywall in numerous areas. It is recommended that a licensed Mold remediation contractor (one such as A Hold Of Mold Environmental) be called in to remove the affected drywall and evaluate any further damage. At this time the source of moisture from the window, siding, drainage issues, grading, should be addressed.
