**AGENDA**  
**ENVIRONMENTAL ADVISORY BOARD**  
**CITY OF PORT ORANGE**

**SUBJECT:** Historic Tree Removal – Crystal Lake Business Park 1101 Reed Canal Road

1. Exhibit 1 – Conceptual Development Plan, Tree Survey and Arborist Report

Subj: Historic Tree Evaluations

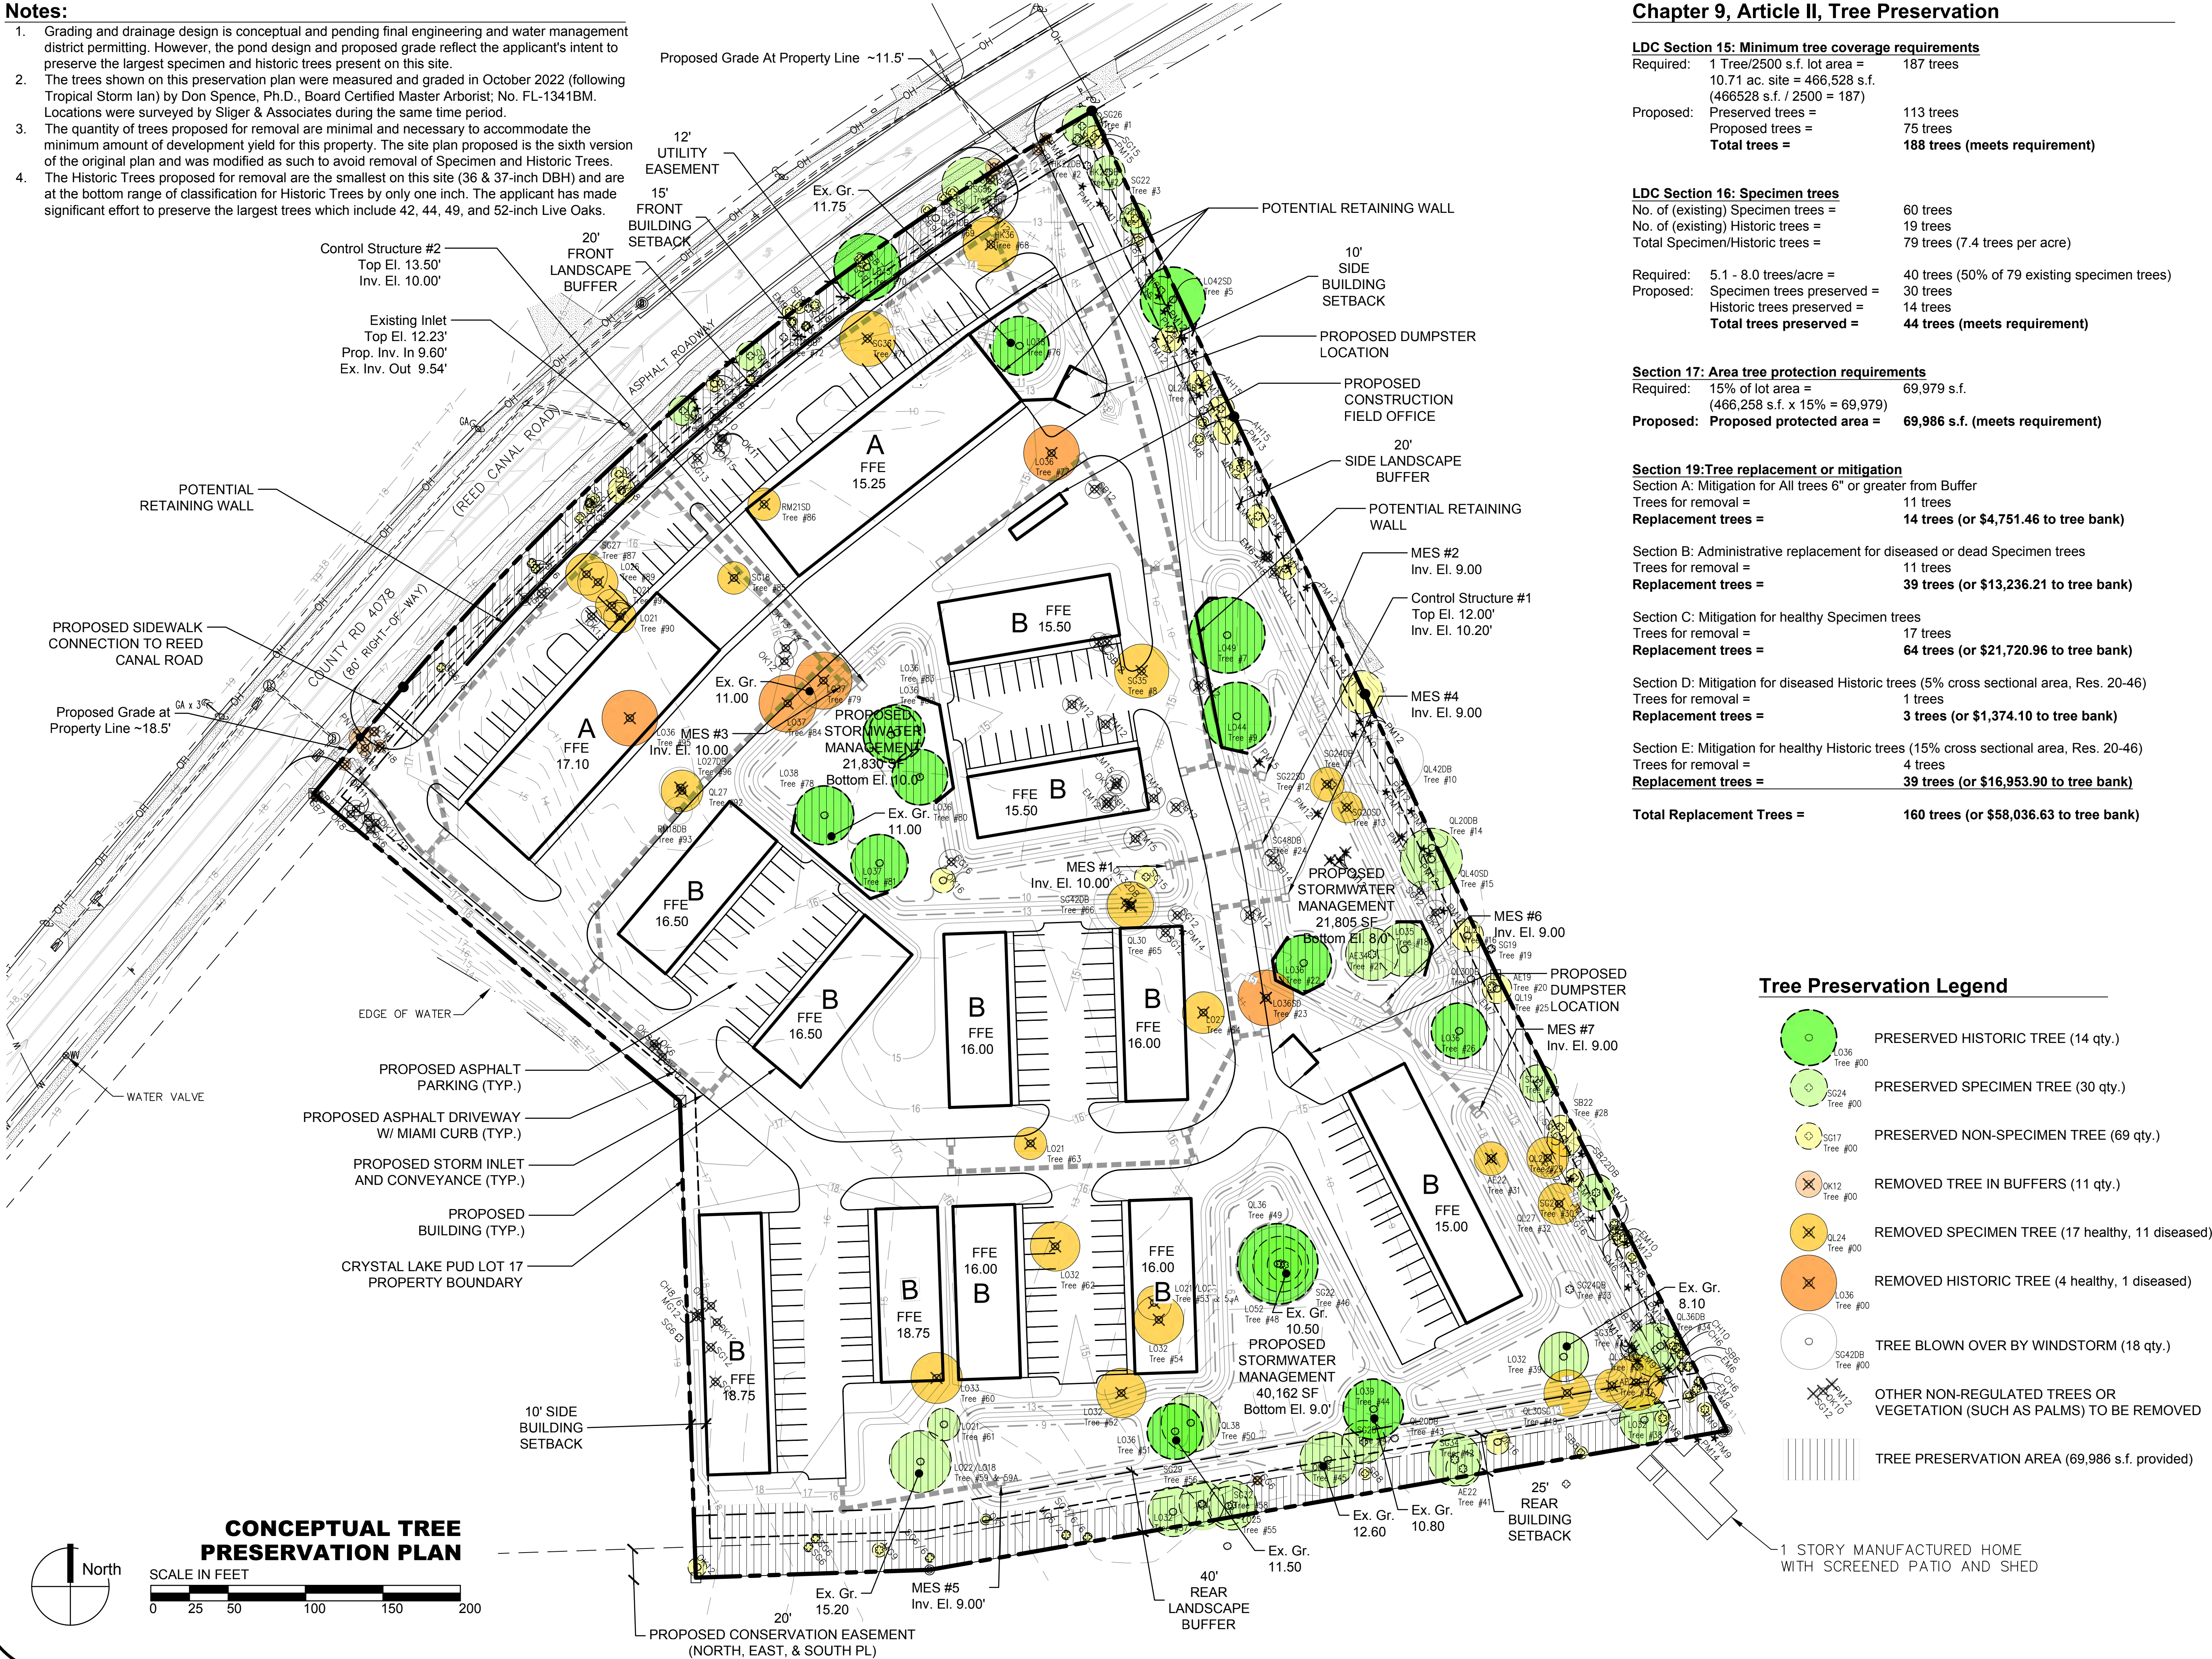
Notes:

- Grading and drainage design is conceptual and pending final engineering and water management district permitting. However, the pond design and proposed grade reflect the applicant's intent to preserve the largest specimen and historic trees present on this site.

- The trees shown on this preservation plan were measured and graded in October 2022 (following Tropical Storm Ian) by Don Spence, Ph.D., Board Certified Master Arborist; No. FL-1341BM. Locations were surveyed by Sliger & Associates during the same time period.

- The quantity of trees proposed for removal are minimal and necessary to accommodate the minimum amount of development yield for this property. The site plan proposed is the sixth version of the original plan and was modified as such to avoid removal of Specimen and Historic Trees.

- The Historic Trees proposed for removal are the smallest on this site (36 & 37-inch DBH) and are at the bottom range of classification for Historic Trees by only one inch. The applicant has made significant effort to preserve the largest trees which include 42, 44, 49, and 52-inch Live Oaks.

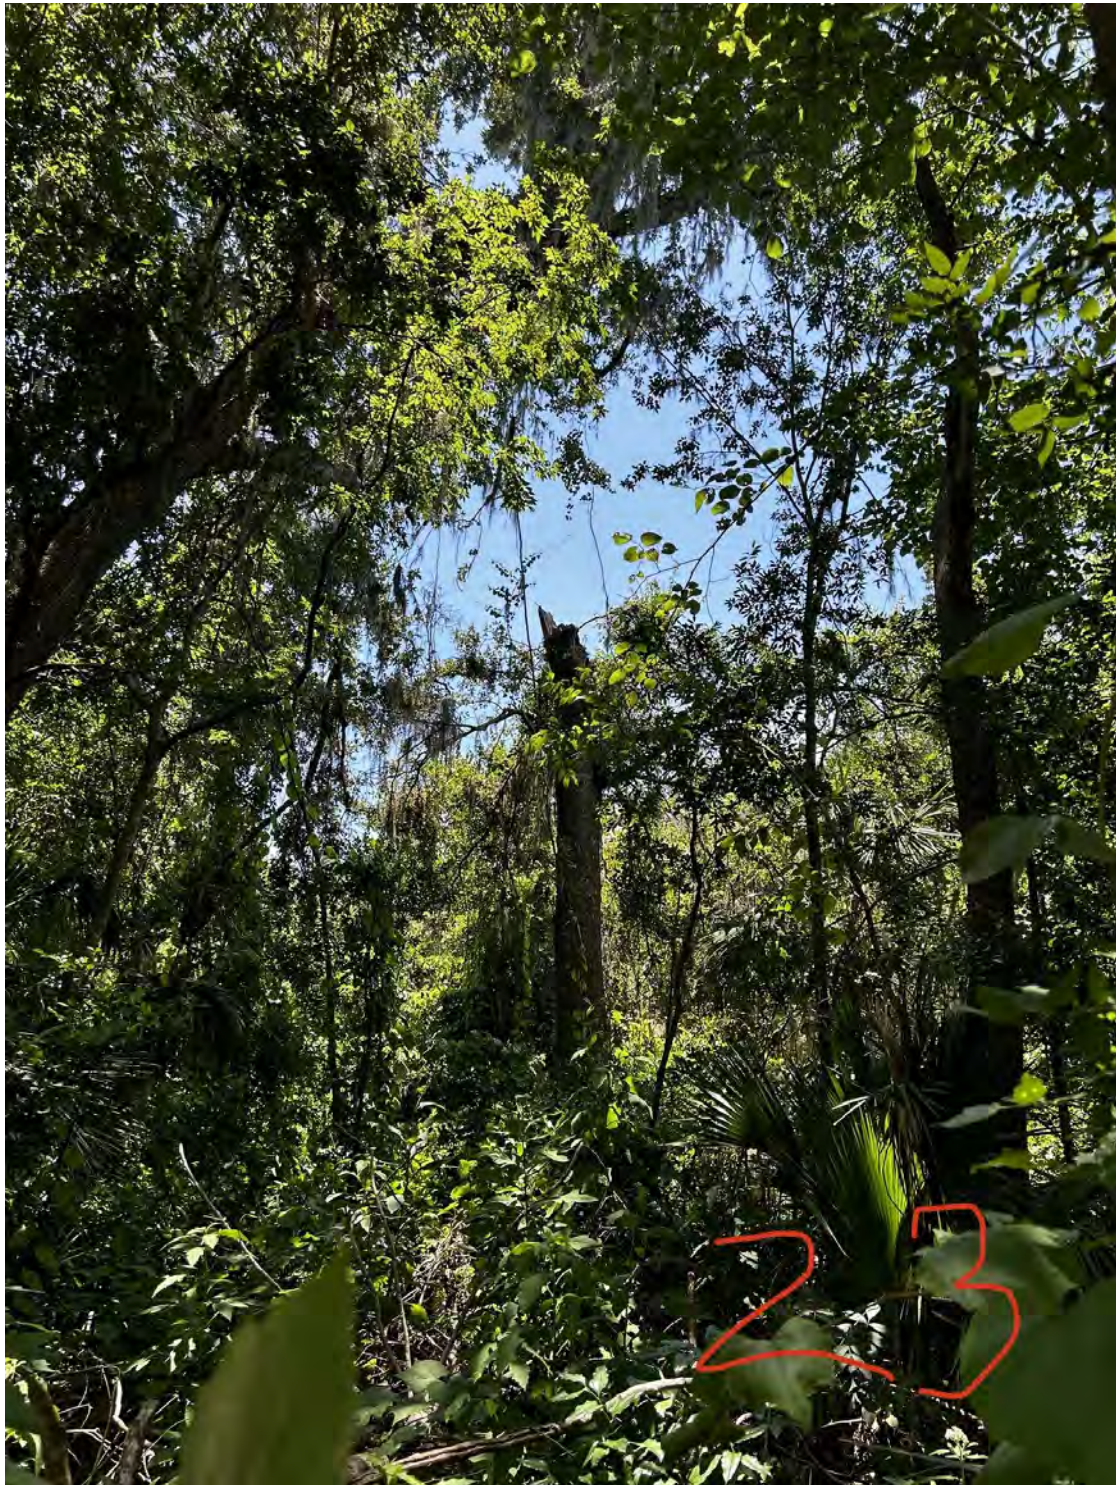
Tree 23

| Tree No. | DBH | Species | Roots | Trunk | Limbs | Canopy | Comments |
|---|---|---|---|---|---|---|---|
| 23 | 36 | Live oak<br><i>Quercus virginiana</i> | 4 | 1 | 1 | 1 | Tree has broken midway up the trunk, tree is dead. |

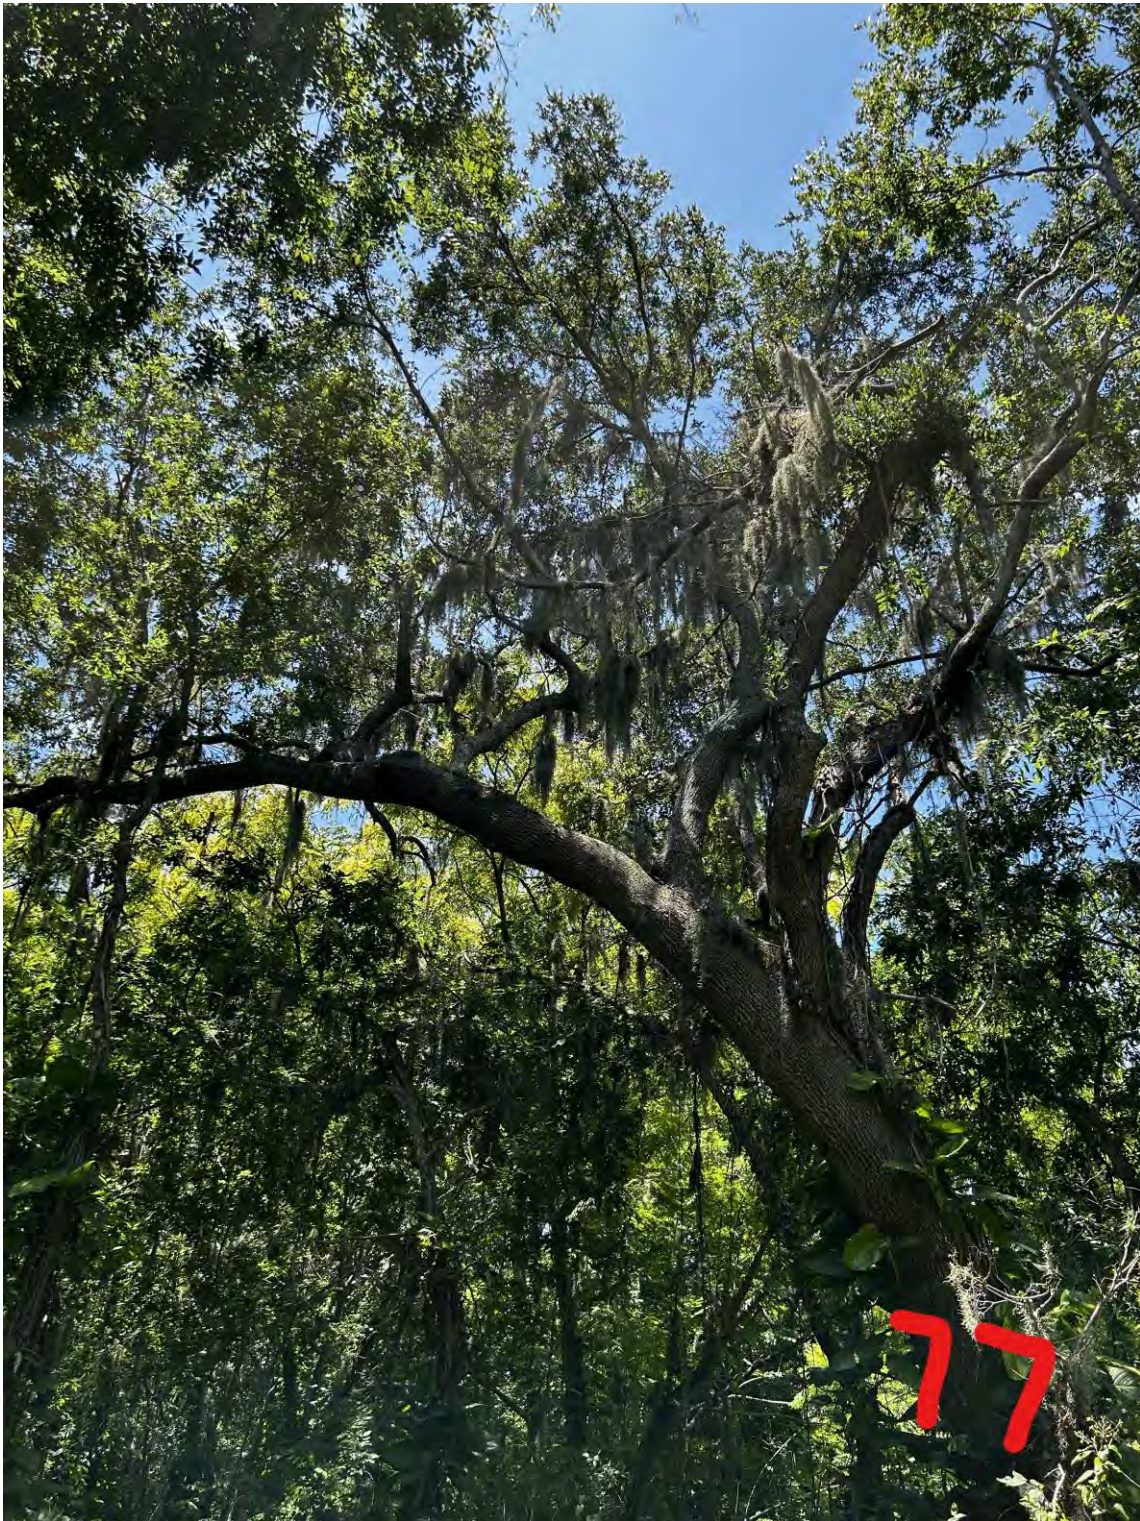
Tree 77

| Tree No. | DBH | Species | Roots | Trunk | Limbs | Canopy | Comments |
|---|---|---|---|---|---|---|---|
| 77 | 36 | Live oak<br><i>Quercus virginiana</i> | 4 | 2 | 2 | 2 | Overall, the tree is health, however, it has thinning canopy with broken limbs and is leaning heavily to the southeast. |

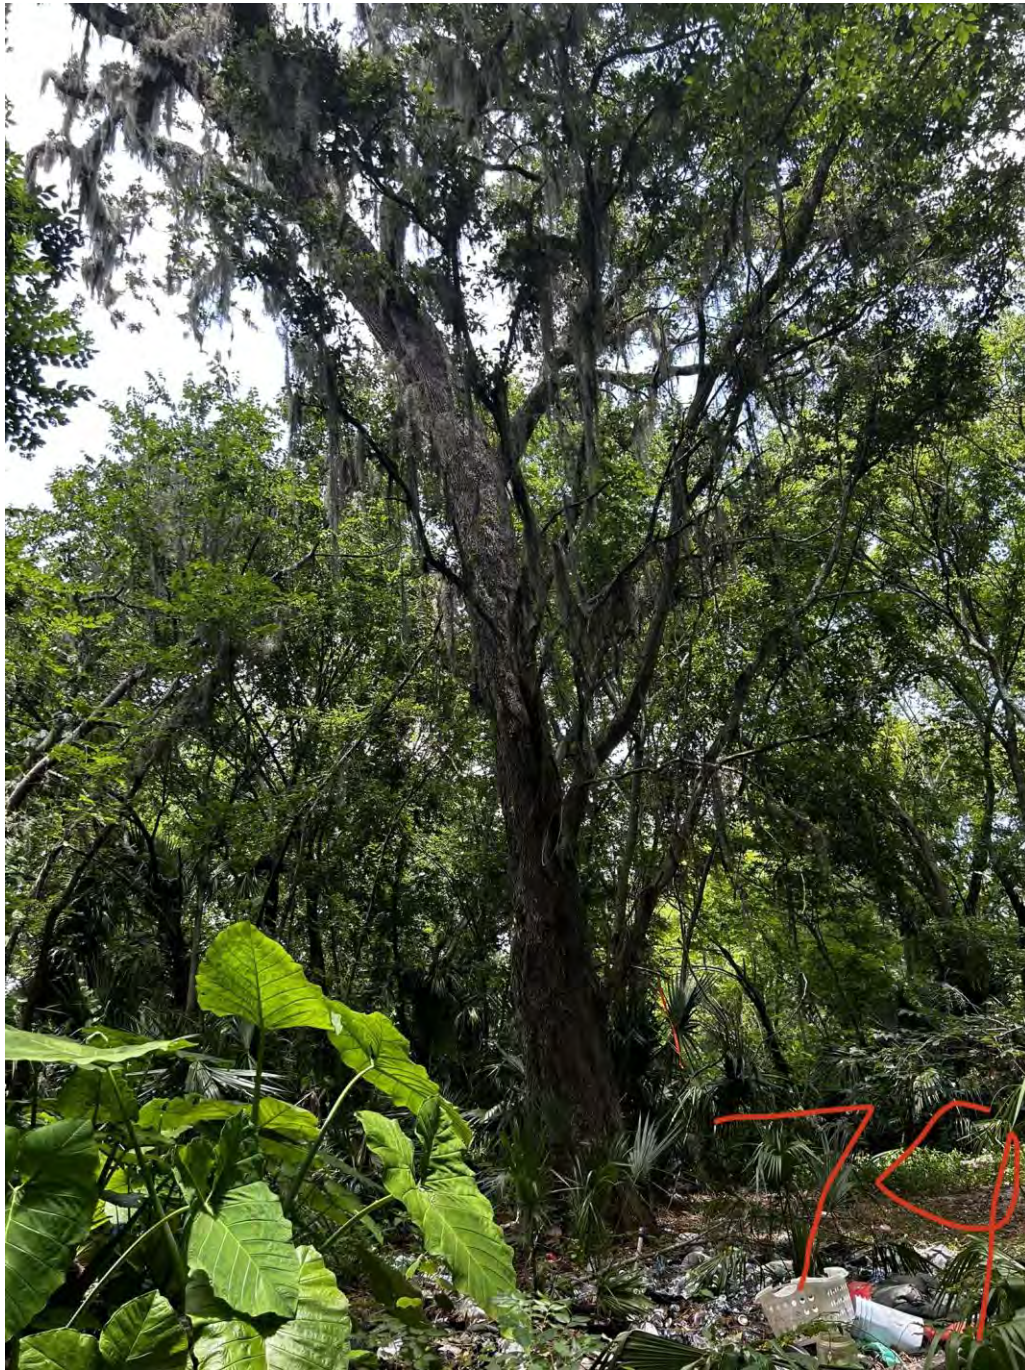
Tree 79

| Tree No. | DBH | Species | Roots | Trunk | Limbs | Canopy | Comments |
|---|---|---|---|---|---|---|---|
| 79 | 37 | Live oak<br><i>Quercus virginiana</i> | 4 | 3 | 3 | 2 | Overall, the tree is health, however, it has thinning canopy with broken limbs to the extent that most of the canopy is missing on the west side of the tree. The tree has a lean to the northwest. |

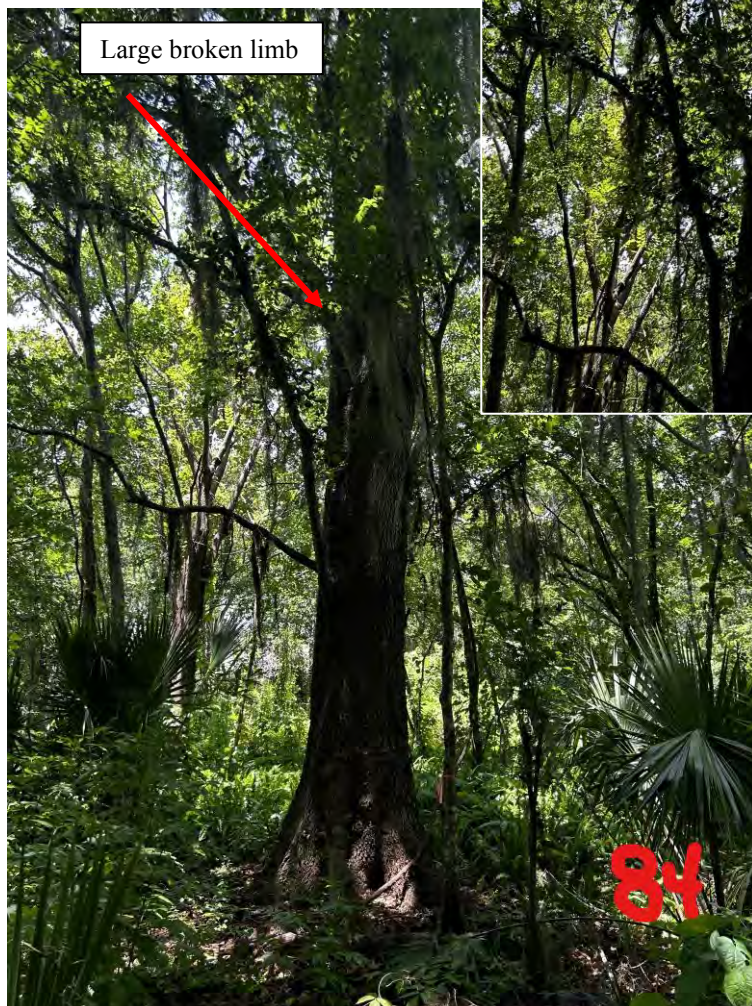
Tree 84

| Tree No. | DBH | Species | Roots | Trunk | Limbs | Canopy | Comments |
|---|---|---|---|---|---|---|---|
| 84 | 37 | Live oak<br><i>Quercus virginiana</i> | 4 | 2 | 2 | 2 | Tree is healthy but has a large dead/broken co-dominant leader in the canopy, which is also thin with broken branches. |

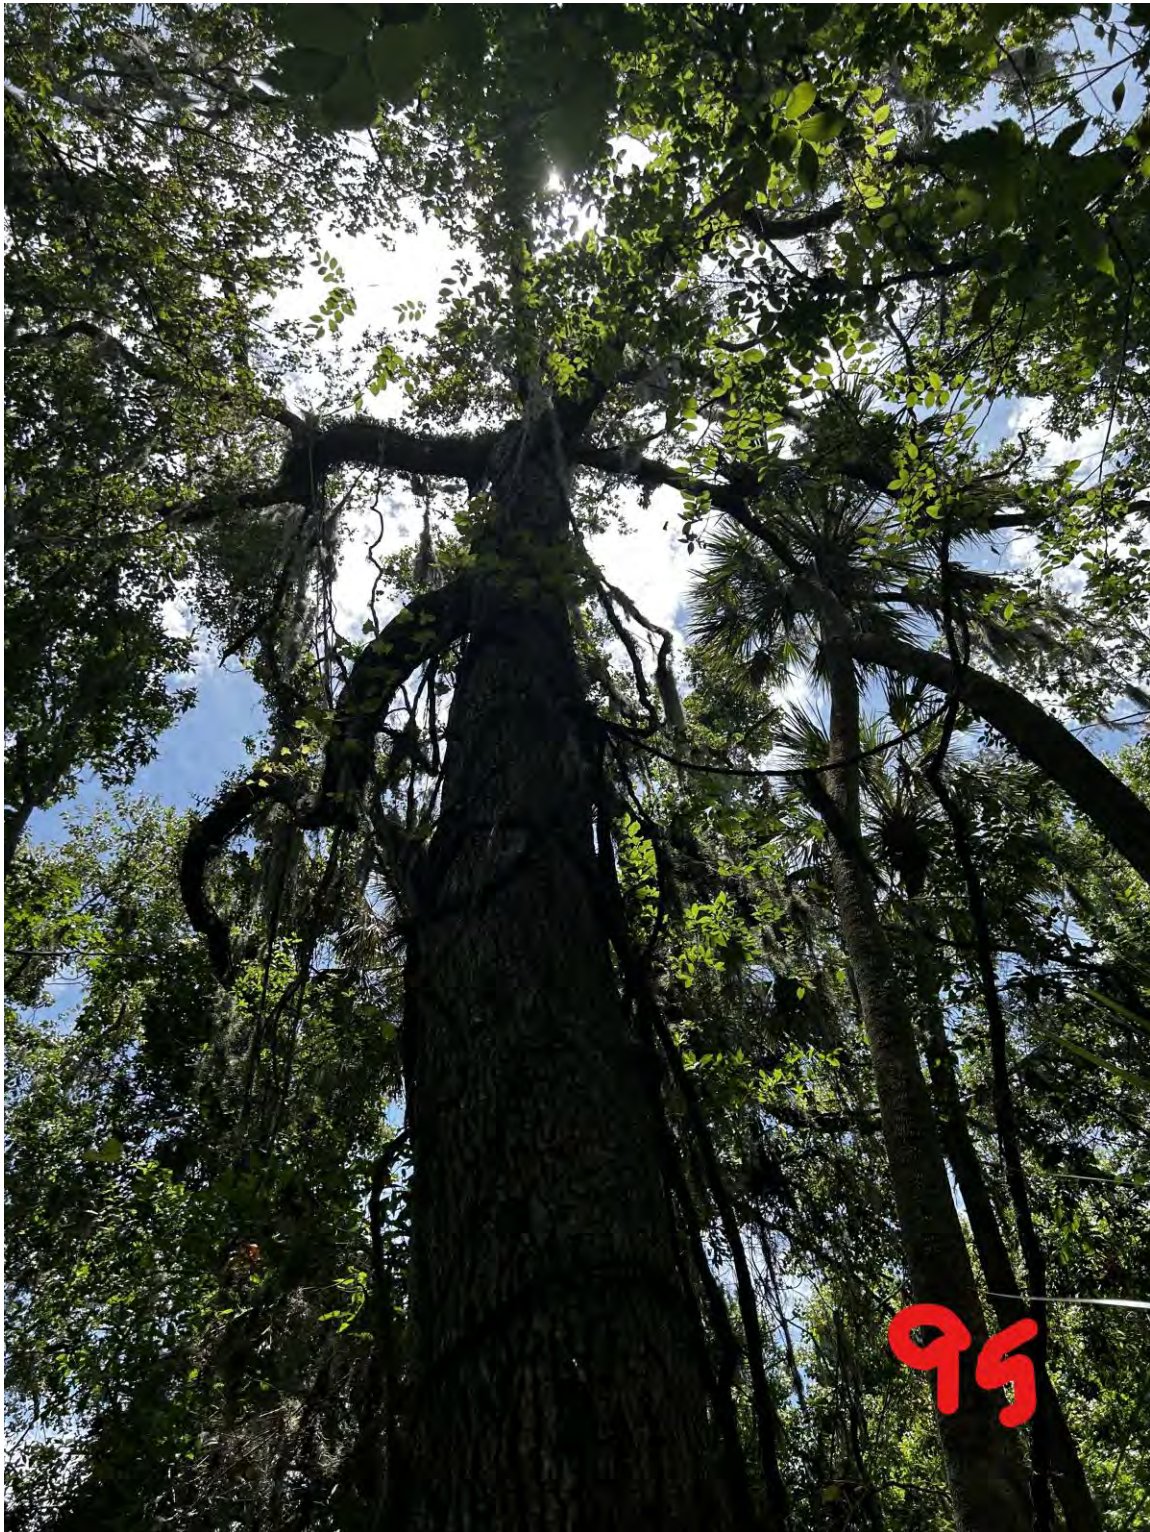
Tree 95

| Tree No. | DBH | Species | Roots | Trunk | Limbs | Canopy | Comments |
|---|---|---|---|---|---|---|---|
| 95 | 36 | Live oak<br><i>Quercus virginiana</i> | 4 | 3 | 3 | 2 | Tree is healthy, however the tree's canopy is sparse and there are some broken branches. |
